BULLET PROOF!

The Turbo Hydra-matic 200-4R and performance do mix. Level 10 Performance shows us how.

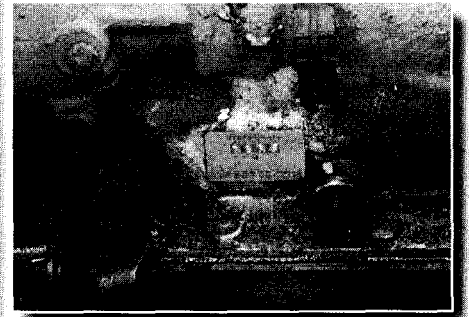
First, make sure your transmission is the proper Turbo unit. Unless you are the original owner, a substandard non-Turbo unit may have found its way under your car. Check the identification plate on the driver's side, right behind the shifter linkage; it should read "7BRF." This will tell you that you're starting out with the right one, as Turbo cars had different valve bodies and clutch assemblies than standard non-performance 200-4Rs.

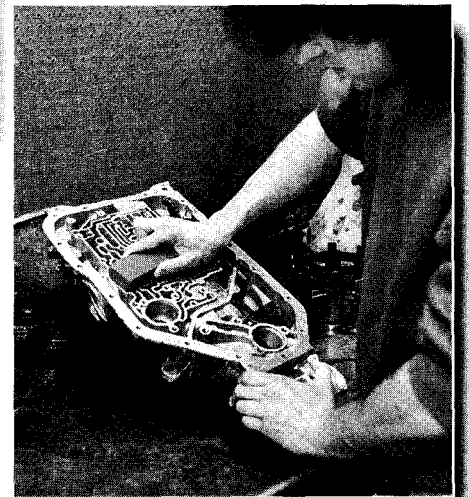
With the transmission completely disassembled, the bare case is laid on its back and the mating surface for the valve body is checked for straightness. A flat honing stone is used to remove any burrs or sharp edges from the surface. The case is then thoroughly cleaned in a washer. A clean transmission will be a happy transmission—the more you cleanse the parts and the work environment, the better the results.

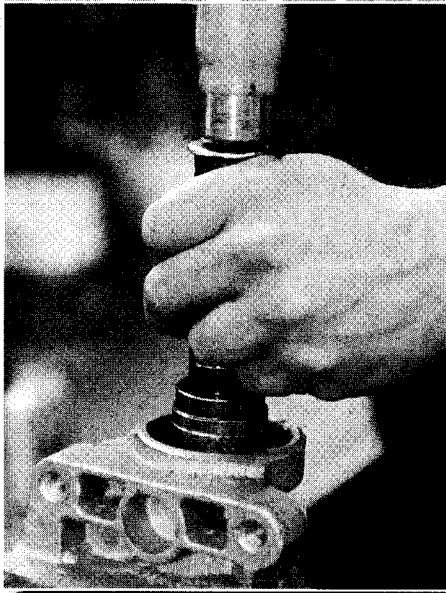
Inspect the rear output shaft bushing and replace, if necessary. Level 10 uses a special type that offers better lubrication. Use of a proper installation tool is absolutely necessary, or damage will result.

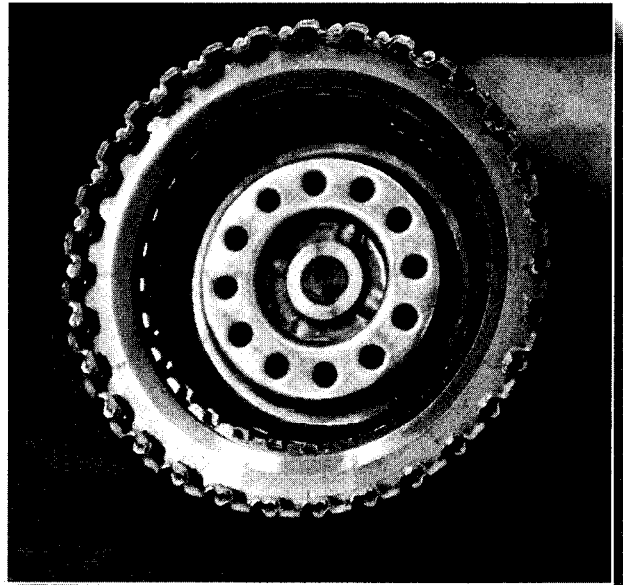
Most transmissions, like the 200-4R, use a forward clutch to engage all the forward gears. This forward clutch assembly had a retaining plate that was damaged due to a low fluid condition (note cracks). The fatigued part was then removed from the clutch pack.

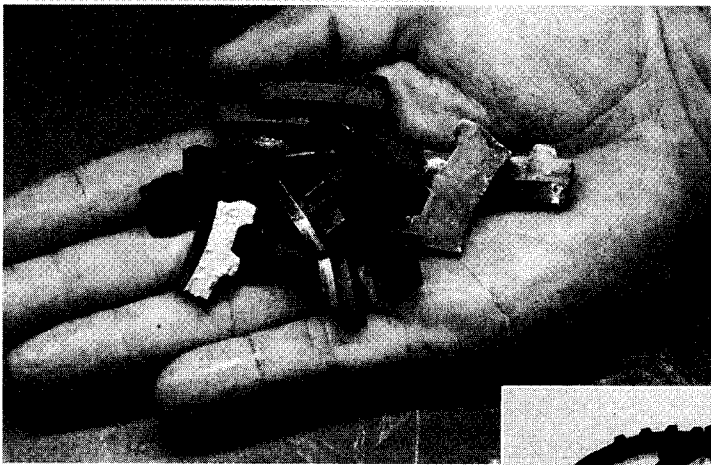
Here you can see the retaining plate that literally fell apart once its snap ring was removed. Considering it is made of cast iron, you can see how much stress is placed on some of these parts if there is insufficient fluid in the pan.

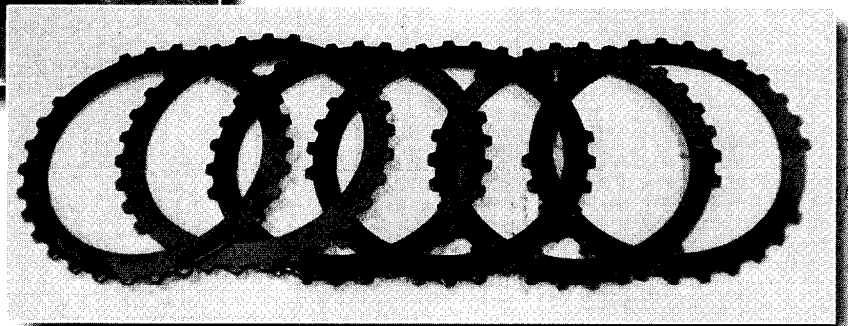
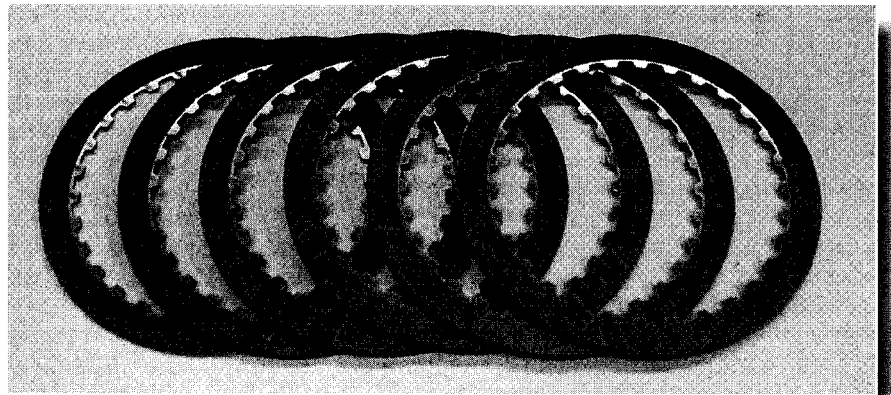
Here are the preferred steels used in the clutch packs. These steels are coated in Kolene, which increases the coefficient of friction, or, in layman's term's, "bite" on the friction material of the clutches. When a clutch pack engages, high-pressure transmission fluid is sent from the valve body to squeeze on a set of these Kolene steels. It then locks up with alternating clutch plates that have friction material on them-kind of like a clutch pack sandwich.

These Raybestos Blue Plate Special clutch plates replace the factory clutch discs. With the Kolene steels, more friction contributes to a clutch pack that can withstand up to three times more torque for a given amount of surface area. Level 10 uses them in all high-performance Turbo Buick direct clutch packs.

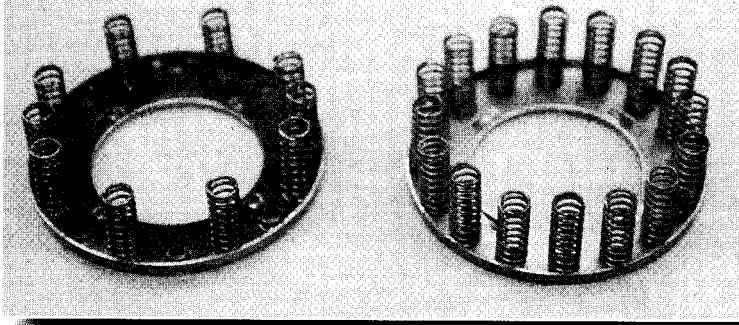
These springs are located inside the direct clutch pack. Together, they release the application plate. More springs make for a quicker release, and fewer springs promote a slower release of third and fourth gears. Although there is no performance benefit, it can make for smoother downshifts. Since we're using a new accumulator for third, these added springs will balance out the requirement for the proper release timing of direct (third).

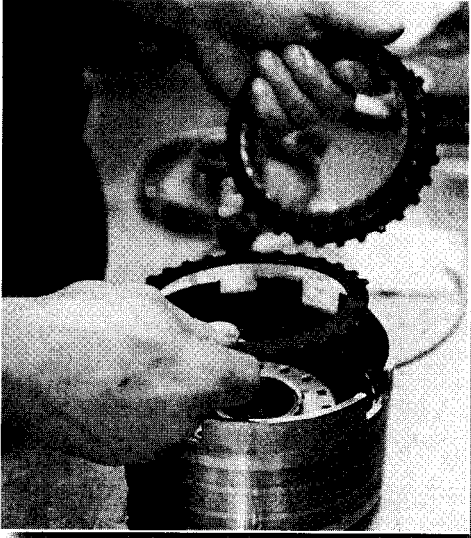
With the new return springs in place, we reassembled the direct clutch pack assembly, as well as the rest of the gears. With the application plate placed in first, insert (in alternating order) clutch discs and steels, starting with a clutch disc, and end with a clutch disc against the end plate. A snap ring then holds it all together:

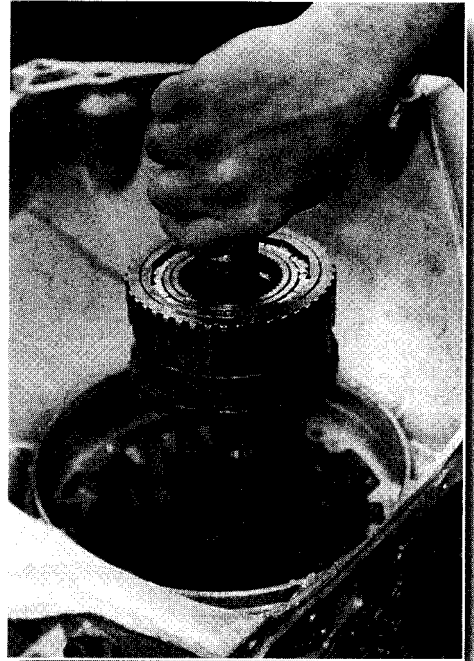
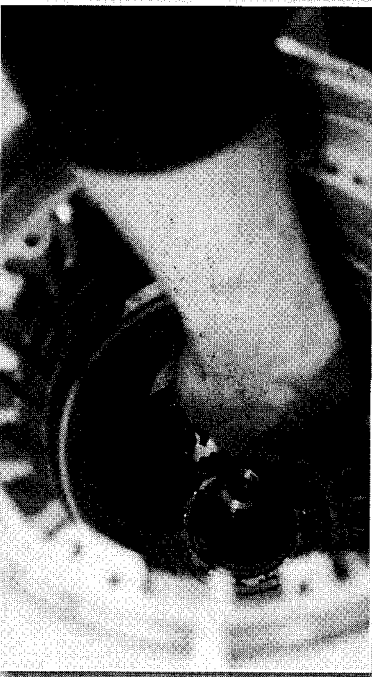
With the case in its bench fixture, we inserted the output shaft and low/reverse sprag. The external splines of the sprag align with the low/reverse clutch assembly splines. Then the clutch engages it or releases it to the splines inside the case. Right below the sprag is the parking pawl ring which, when locked by the pawl that's mounted to the case in the rear, locks the output shaft to the case for park.

Next, we installed the low/reverse planetary gearset and its clutch assembly, which goes into the case. Seven steels and six clutches go down here, with a wave steel covering it all. Incidentally, a wave steel looks like a large wave washer and in this case, acts as a cushion to make sure the clutch assembly parts do not rattle in the case and are always ready for application with a pre-determined preload.

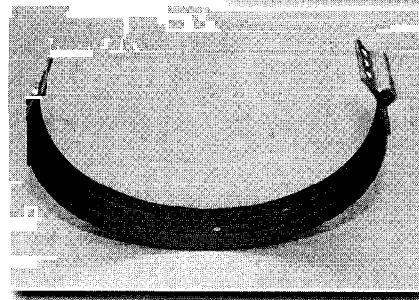
Although different transmissions use different methods to apply a selected gear, a band was used to wrap the direct clutch drum in the 200-4R to engage second. We installed this Raybestos band, making sure it was positioned properly in the case and aligned with the servo piston access hole.

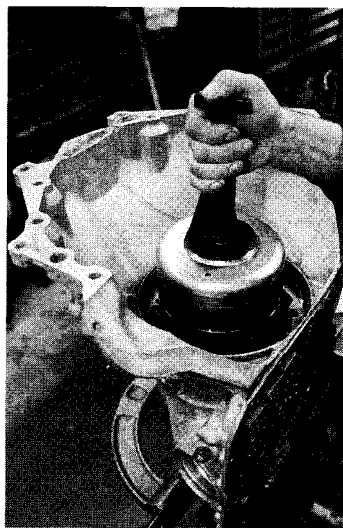
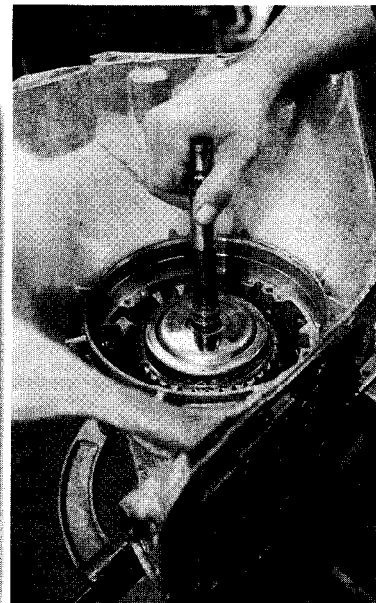
It is often much easier to assemble a transmission with the proper tool for the specific unit. Sometimes it is a necessity, sometimes not, but either way, it is almost always easier. Here, our direct clutch assembly and drum is lowered into place with a holding tool. It locks to the inside of the assembly

Finally, our 200-4R is starting to look like a full unit. The input shaft is connected to the overdrive assembly. Although the engine's torque reaches fourth gear first, overdrive is not operated until its band is applied. This causes the direct and forward assemblies to be driven first.

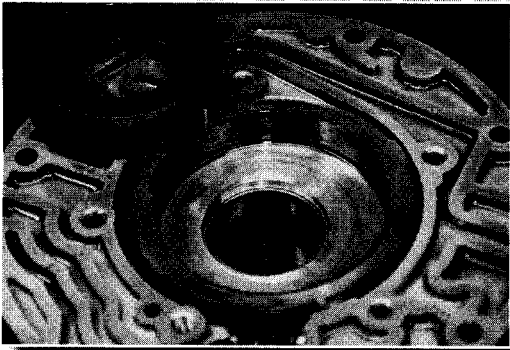
Before the front pump can be installed, it must be disassembled and checked on the bench. The pump's operation is critical for the durability of the tranny. This 7-vane positive displacement pump is also a variable displacement type. The outer ring that the pump vanes spin in moves to vary pump output. At low speeds such as idle and decel, the pump's output is decreased to improve fuel economy (less drag on engine to drive pump) and provide smooth operation. With the throttle mashed (sensed by the TV cable), the pump's output goes to max and provides high fluid volume and pressure to the rest of the transmission to give you tire-baking shifts and torque converter lockup. Make sure everything moves freely and all seven vane elements are in good shape.

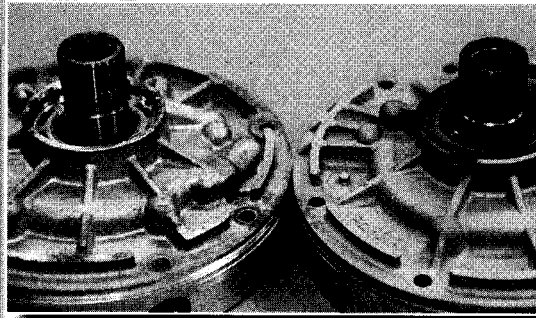
The most common leak for a 200-4R is in the front seal. Pat Barret uses a seal that not only presses in, but has locking tabs around it to make sure it won't work its way loose. This would be a good time to change all the scarf seal... on the center support shaft and check for wear on the input shaft bushing. Here, we can view the stator support shaft on the left, which has damaged splines. The new assembly on the right is ready for use.

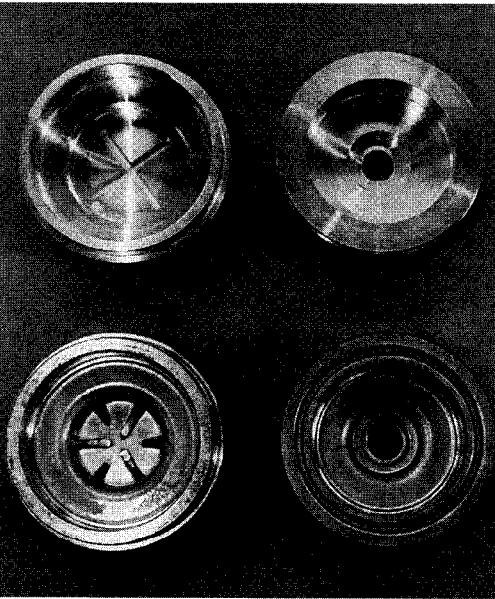
The intermediate band application servo is replaced with Level 10's new billet servo assembly (top). The advantages of a larger servo include a more positive first-to-second shift a cleaner second-to-third shift and a cleaner third-to-second kickdown. It makes second's application and release swifter and more accurate.

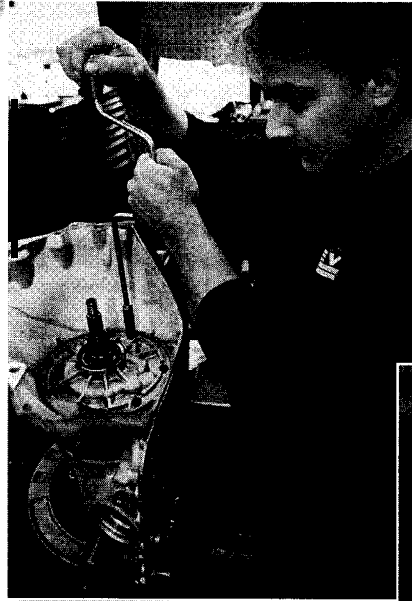
The front cover and pump assembly is slowly tightened to make sure the perimeter seal is seated properly and the hardware inside the case is installed correctly. If a hub assembly is not seated properly, the front cover will never bottom out against the case. We never had a problem with the Level 10 crew spinning the wrenches,

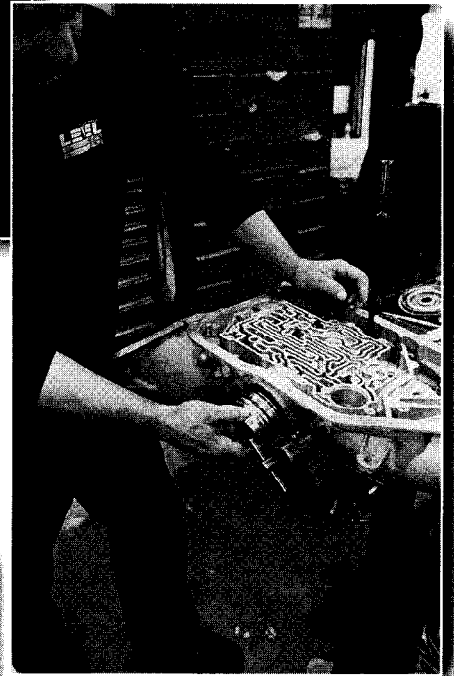
On the side of the case, we inserted the new billet servo and cover with its return spring and lock ring. New replacement-type seals were used as the piston rod was seated against the intermediate band. Check for alignment by looking down through the valve body, or by making sure the tranny still spins freely at the input and output shafts with the transmission in neutral.

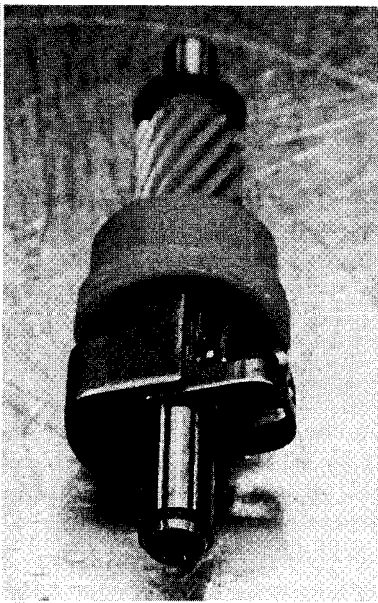
This is the governor. It goes in before the valve body does and provides information to the valve body about the output shafts speed. It has a nylon gear that spins at a 90° angle to the output shaft. As it increases in speed, the whole assembly spins and sends centrifugal weights outward. In some cases, the ball valves in the governor can leak, causing an unwanted elevation in shift rpm. With a magnifying glass you can check the disassembled valve seat for wear to determine if leakage is a problem. If there is no leakage and you want to lower your shift points, a small amount of mass can be added to the smaller centrifugal weight (right side).
